Investigation of Incident
"Accidental Electrical Shock at U4A"

Prepared by W. R. Casey

5/22/02

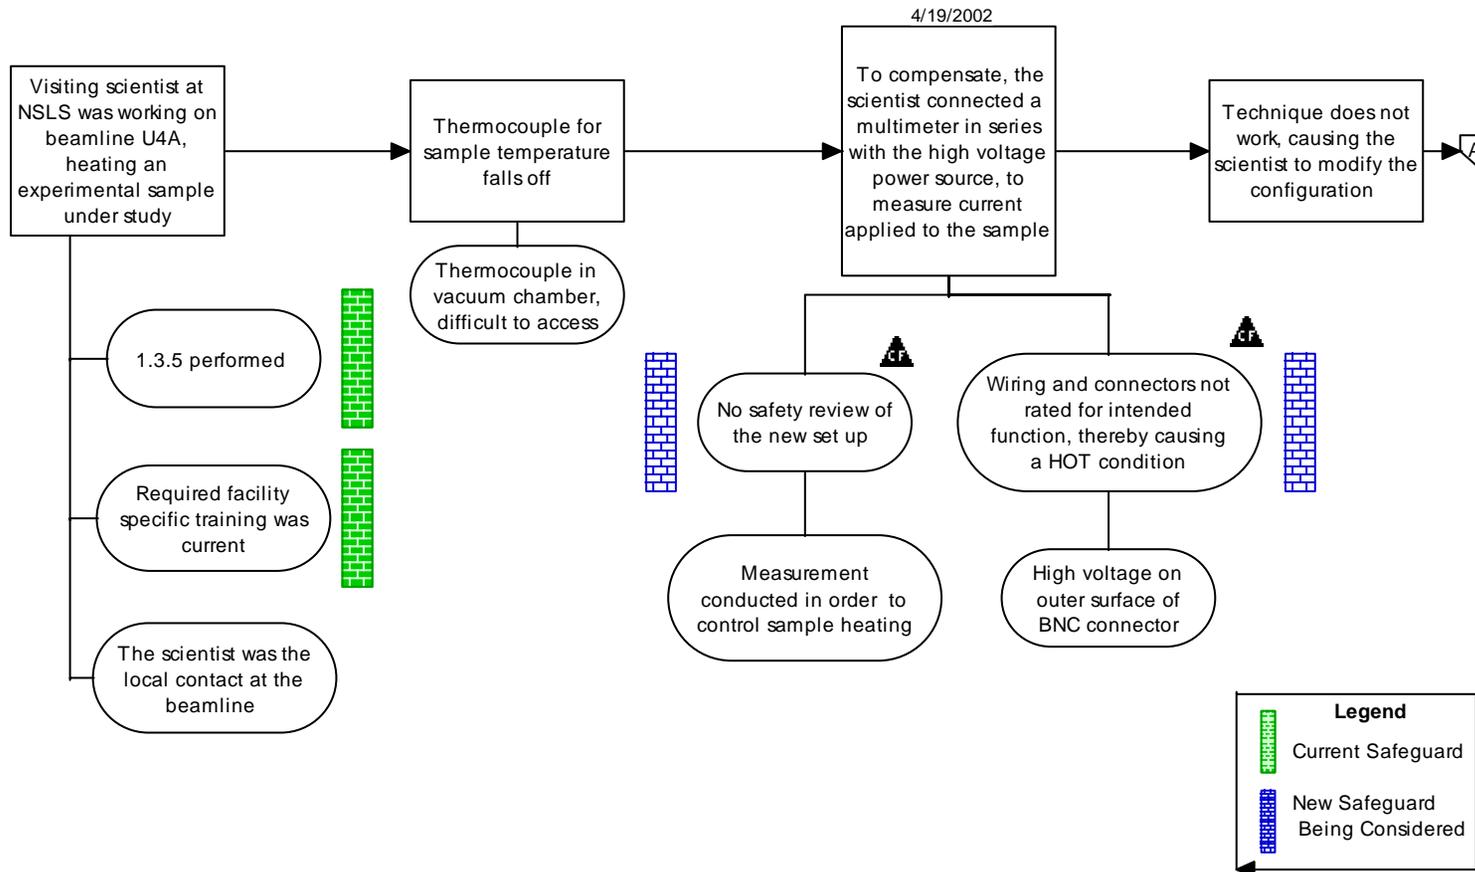
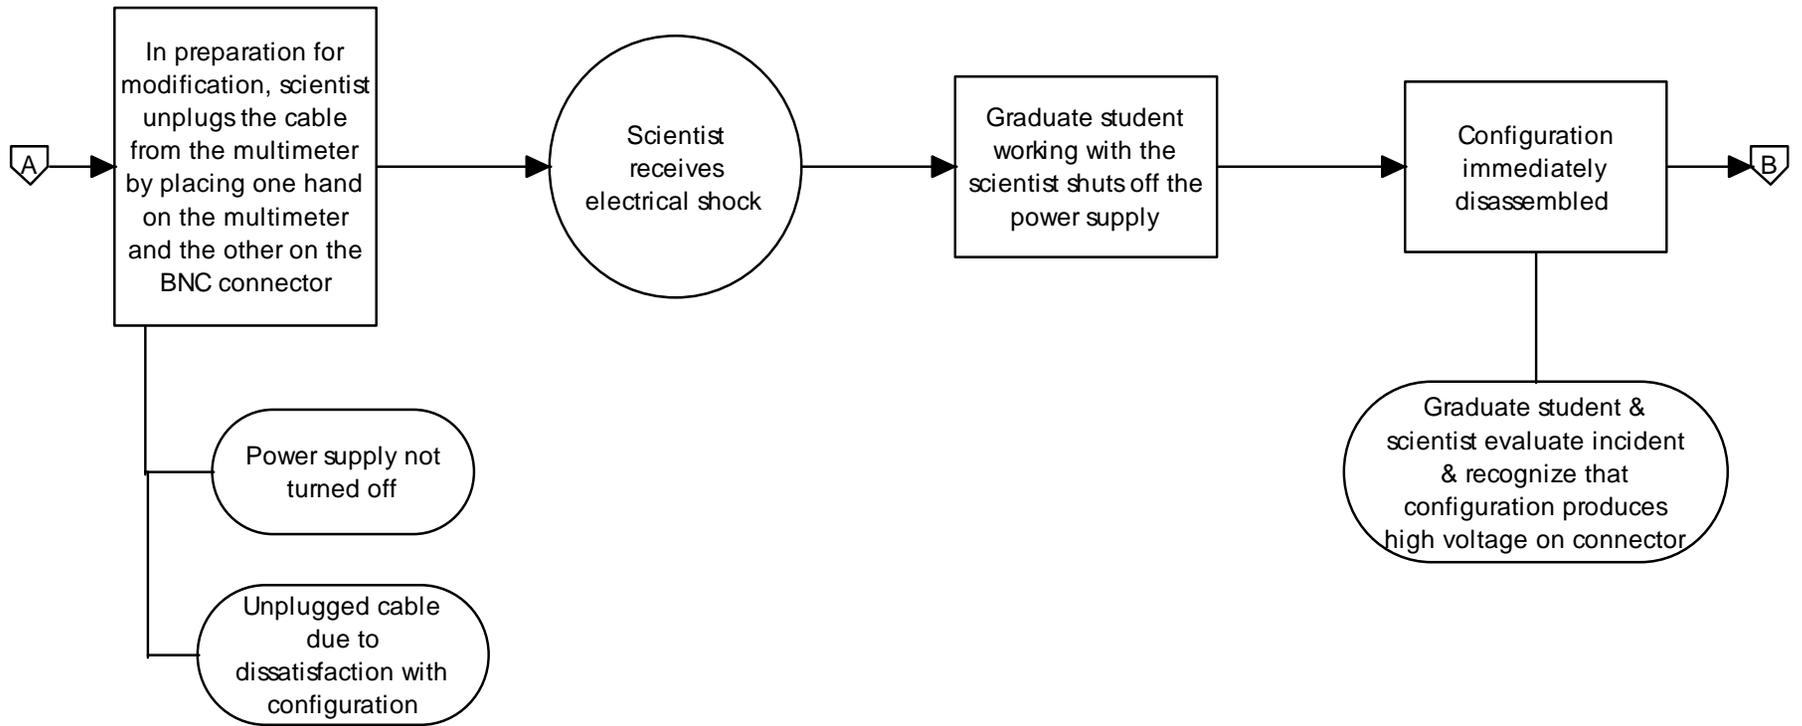
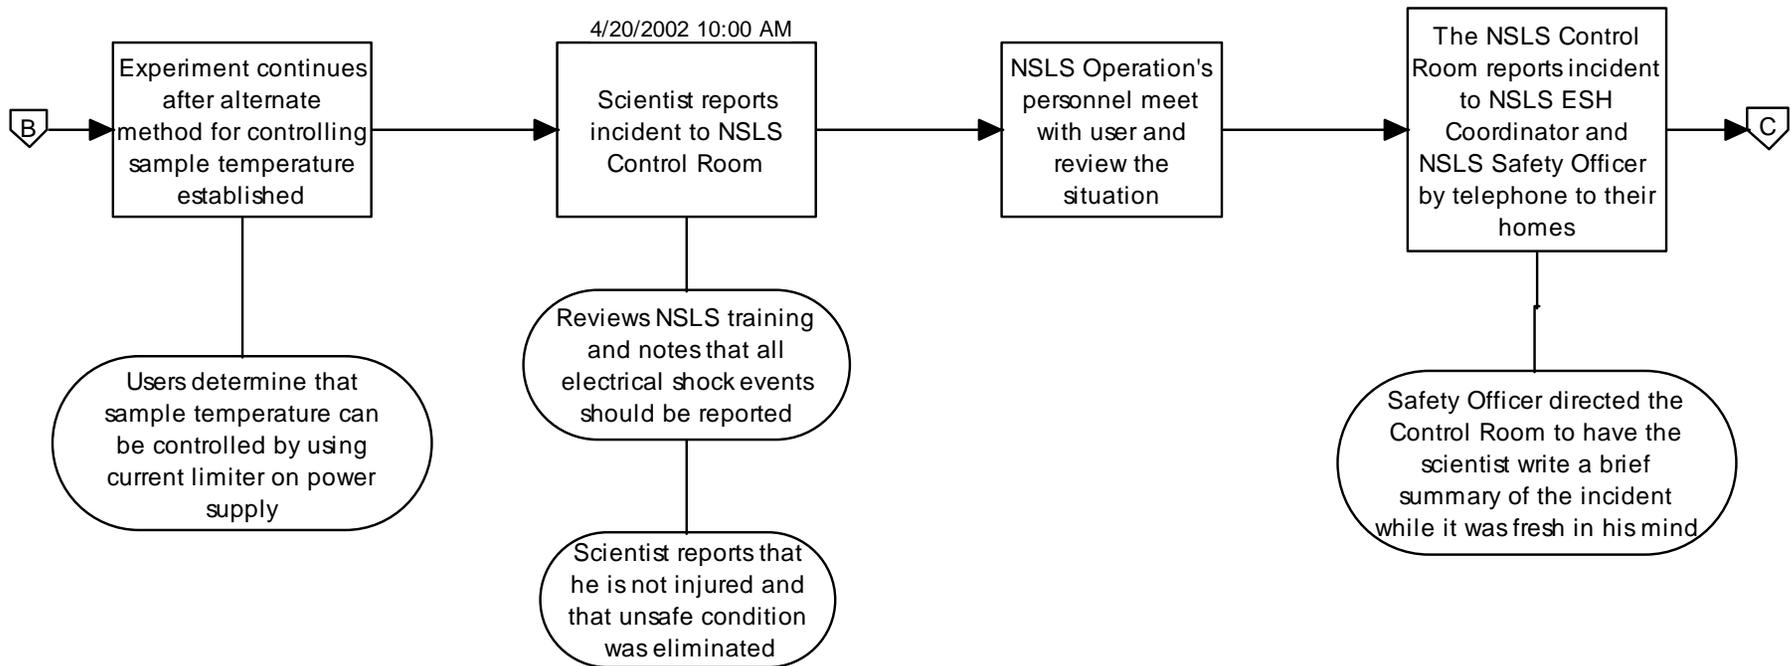
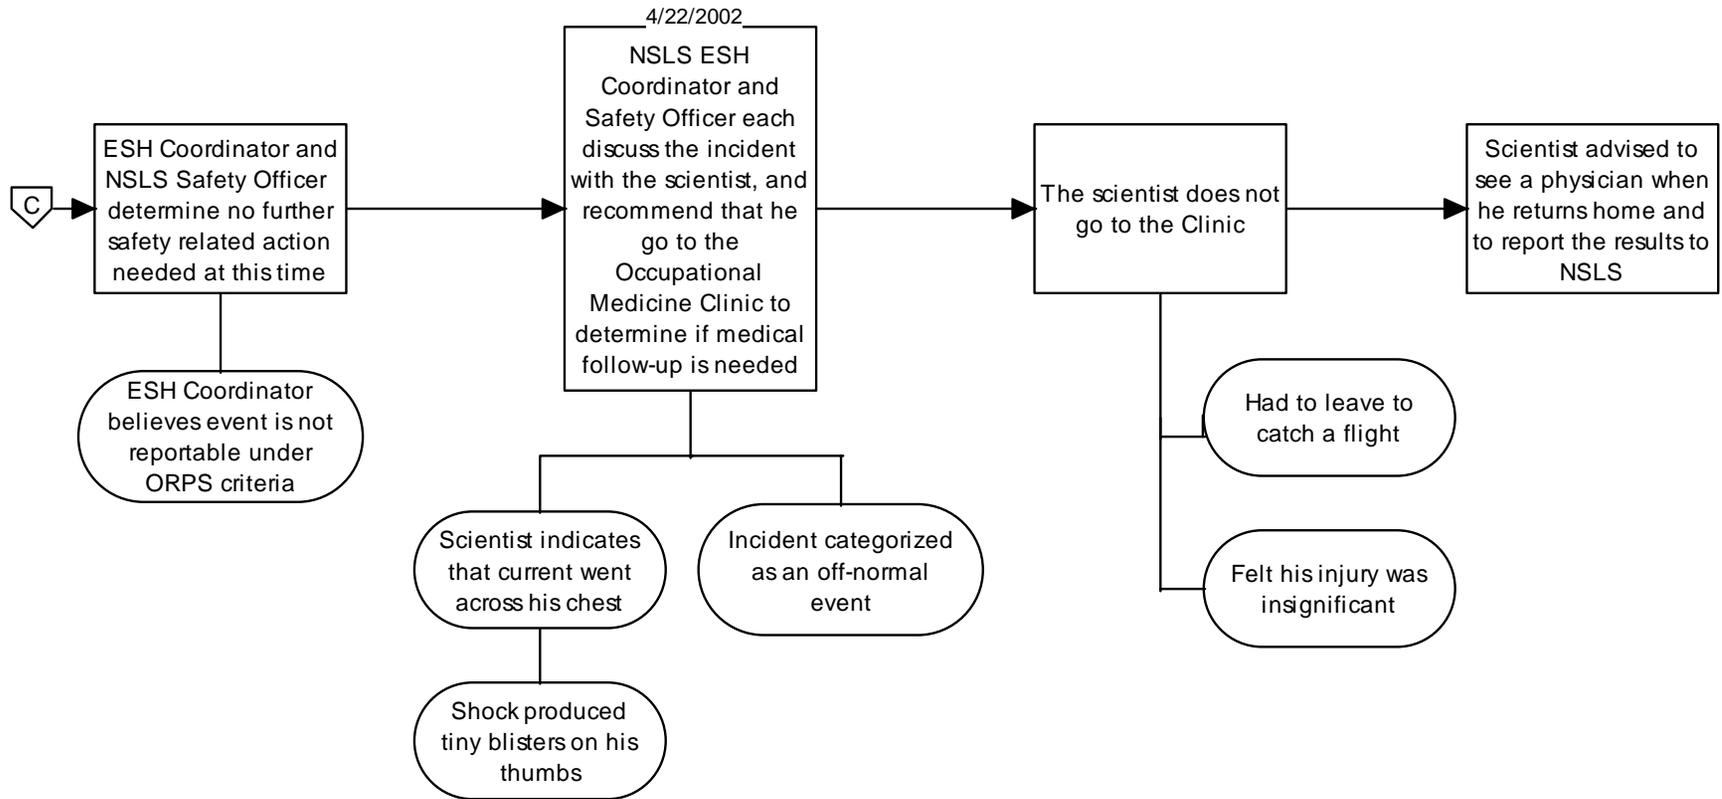
Sequence of Events for Electrical Shock at National Synchrotron Light Source

The sequence of events depicted in Attachment 1 was established in consultation with all involved parties. A causal analysis was conducted preliminarily through a formal process utilizing "Taproot", a commercial computer program developed to support this process. The causal analysis was confirmed through a detailed discussion of the event and its causes at a meeting of NSLS beam line and ESH personnel, members of the Laboratory Electrical Safety Committee, and members of the ESH/Q Directorate.

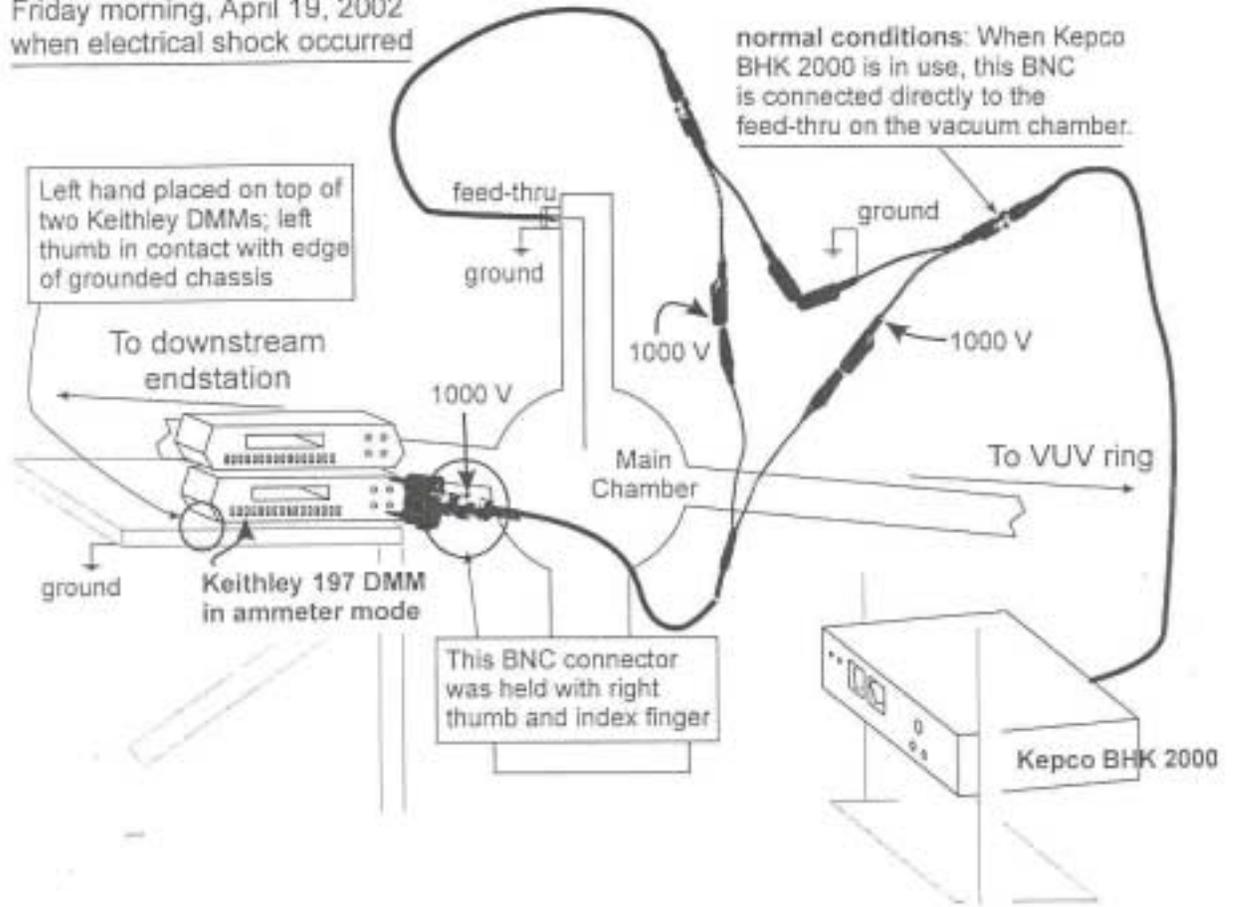
Attachment 2- Schematic of Circuit

- User A reconfigured the normal electrical connections between the power supply and the sample by using signal coaxial cables, BNC connectors, alligator clips and a banana plug as shown in Attachment 2. As a result he introduced equipment that was appropriate for low current and low voltage applications into a high voltage circuit. Both users were clearly aware that several of the surfaces had exposed voltages and sought to minimize the risks by using partially insulated alligator clips and positioning connections on insulated surfaces. However, in their preparation they overlooked the fact that the BNC used to connect to the multimeter was floating at 1000 VDC. The users assembled the components and their connections without review or discussion with NSLS Safety or other beam line personnel.

In an effort to address an operational issue, User A developed a measurement technique that created exposed energized components. When he sought to disconnect the assembly without turning off the power, he contacted a surface energized at 1000 VDC and created a current flow through his body to ground.

1. There was inadequate consideration of the potential hazards associated with the measurement technique that User A was attempting to perform.
2. Wiring and connectors introduced by User A were designed for low voltage applications and were inappropriate for this activity.

U4A conditions on
Friday morning, April 19, 2002
when electrical shock occurred

rated for its service and recommended that the cable be replaced with one rated for service up to at least 2000 volts (the maximum output of the power supply). The cable was replaced with a RG-59 cable rated at 5000 V. They also noted the use of MHV connectors and recommended that they be replaced with SHV connectors. SHV connectors provide better isolation of the high voltage terminal and cannot be connected to low voltage rated BNC connectors. In this incident, the MHV connectors in the original high voltage cable were mated with BNC connectors, which made possible the mixing of high voltage and signal cable equipment.
